# TRAFFIC ACCIDENT HAPPENED ON 01.02.2013, A ROUD 22.00 PM IN RADOVISH, STR. "ST. SPASO RADOVISKI" BEFORE LTS "INTERPLAST" AND EMPLOYMENT BUREAU RADOVISH

Sovreski, V. Zlatko, Prof. Ph.D & Ph.D, Ljupčo Todoroski, Bc., Simeonov, Simeon, Prof. Ph.D

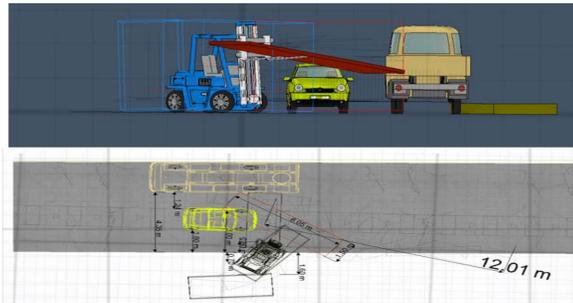
Fig.2 - a contact / contact mechanism

PMV "Folsfagen Lupo" with metal panels realized physical contact of the substrate height of about 1,40m, with metal panels from the scene of the collision on a parabolic trajectory rejected the substrate at a distance of about 12m. Hence that the moment of contact with the metal panels, PMV "Folsfagen Lupo" had contact speed of not less than 81,5 km/h.

At the moment of contact between the metal panels and PMV "Folsfagen Lupo", the forklift only with the front left wheel was on the road surface of 0,8m from the edge of the road, with the front right wheel was on the edge of the road, with the rear left wheel it was of uneven clay of 0,7m, and the rear right wheel of 1,6m all this starting from the right edge of the roadway (see Fig.2)

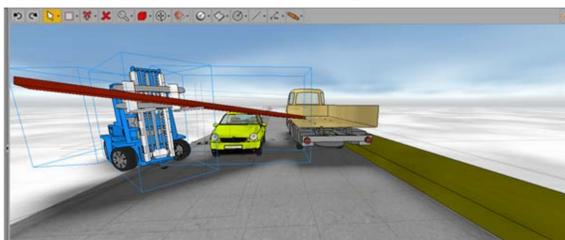
Fig. 2.1 - Mechanism Contact

According to the defined collision position of the forklift and correlated with all the other evidence found at the scene, it appears that in reversing backwards from the lifting position, and onwards to the place of contact, the forklift driver has passed a distance of 2 m moving backwards with a graduate left turn maneuver In a period of time no longer than 2,6 sek. Forklift driver at all times while reversing performed raising of the metal pannel after it huck it with the forks and effectively lift it on a high additionally on a hight of 0,6 (60cm) calculating from the height of the initial hung from the platform of the truck t .E of 1,1m, which means the place of collision position the part where contact with the metal pannel was made, of the asphalt surface was raised to 1,40m, the other part of the metal board was at a height of no less than 1,7m.

The mechanism of contacts made between the metal panels with top-plate roof of the left by PMV Lupo to the conclusion that, just before contact, the metal dashboard plate was tilted from side lev 0,3 m (30 cm) and mean was slipping under the forks of a forklift that was broadcast.
